PROPERTY INSPECTION REPORT

Concerning: Builders say you do not need a third party inspector...., DFW Area, TX 75070
(Address or Other Identification of Inspected Property)

By: Rick Cornick, Lic #6229 01/22/2014
(Name and License Number of Inspector) (Date)

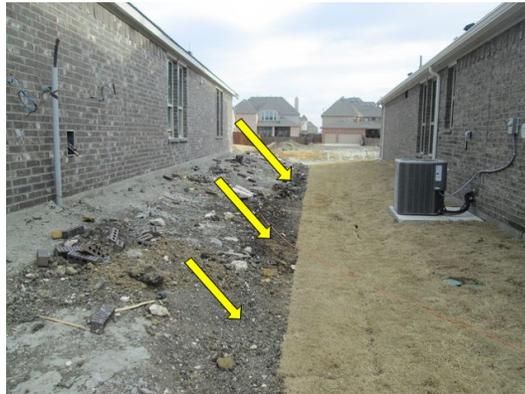
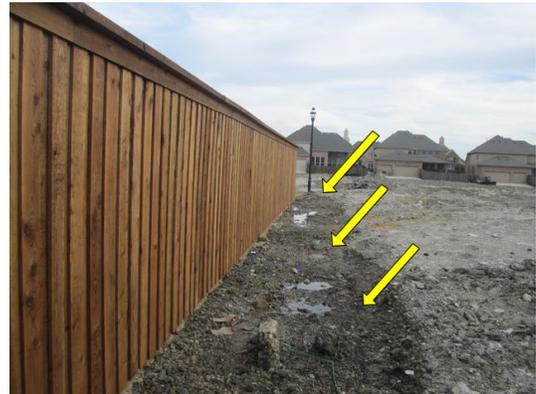
-Drainage does not appear to be adequate at both the East and West property lines (due to on going construction).(See Photo for example)

-Gutter extensions needed to extend the discharges away from the foundation.(See Photo for example)

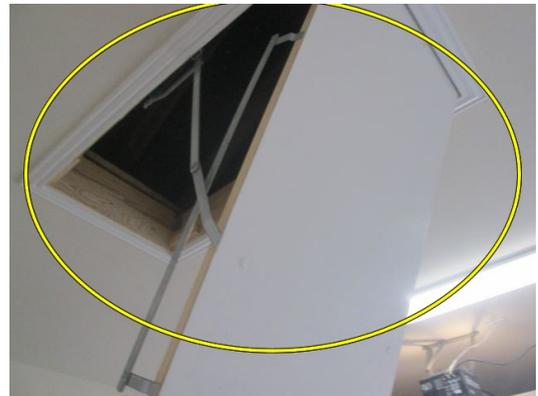
-Attic insulation has not been installed at the time of the inspection.(See Photo for example)

-Garage attic ceiling door/access or trim does not appear to be made from an approved or fire-rated material (or has no fire-rated information present).(See Photo for example)

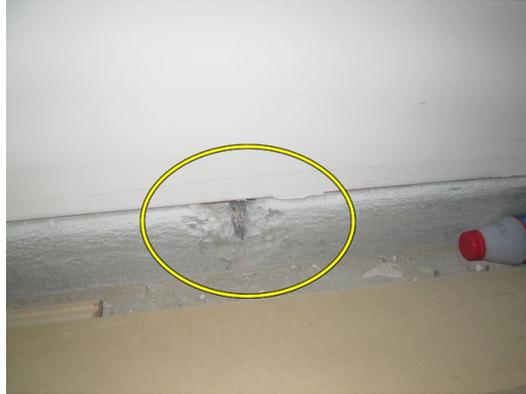
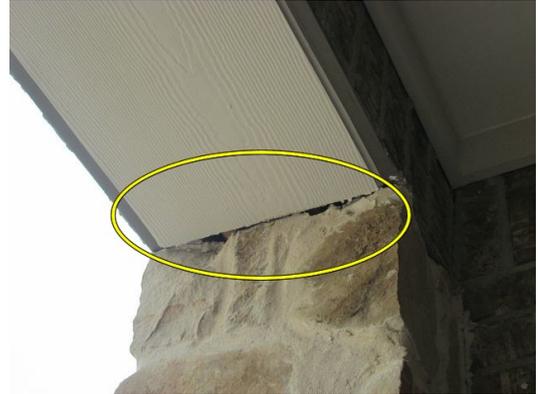
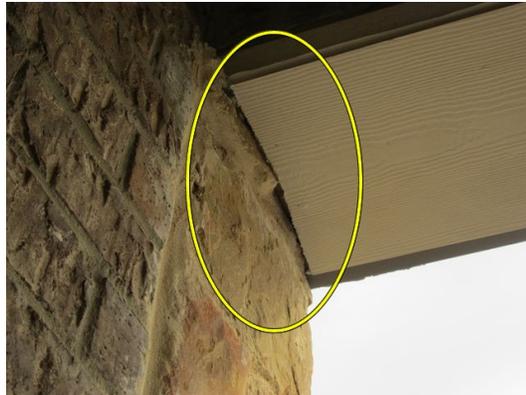
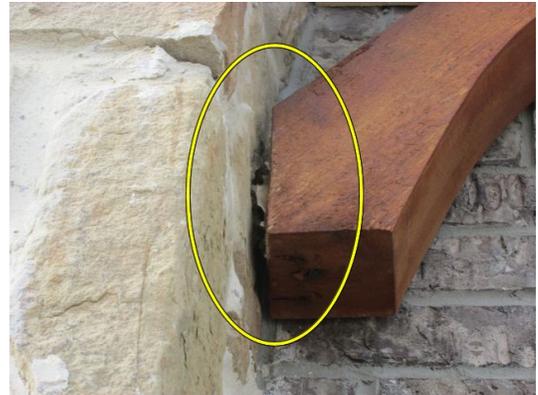
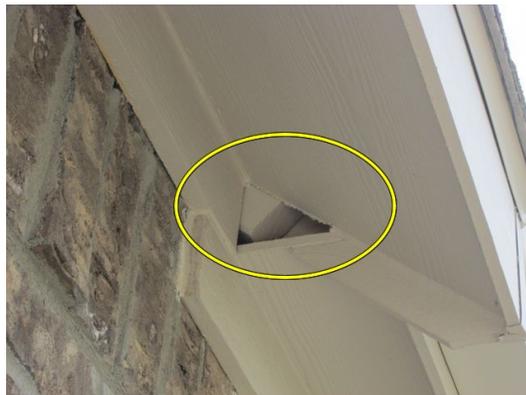
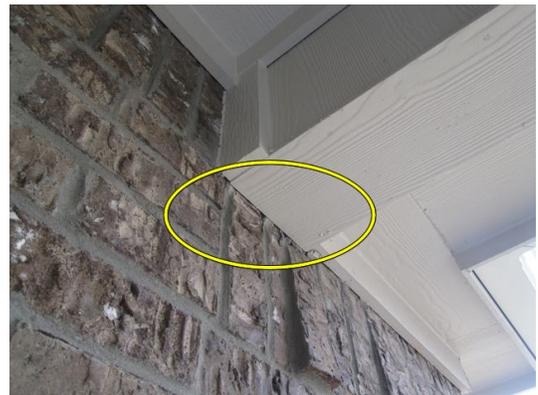
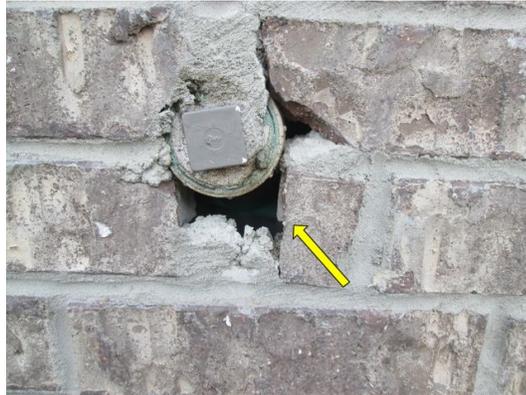
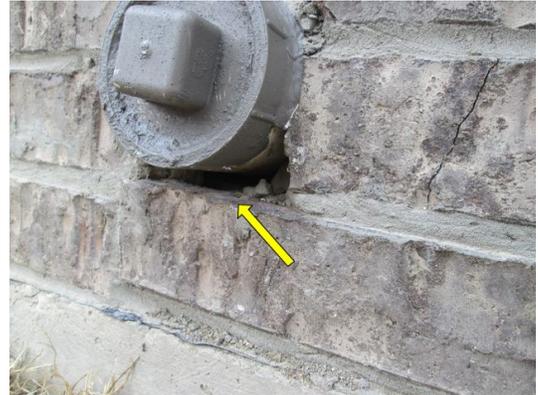
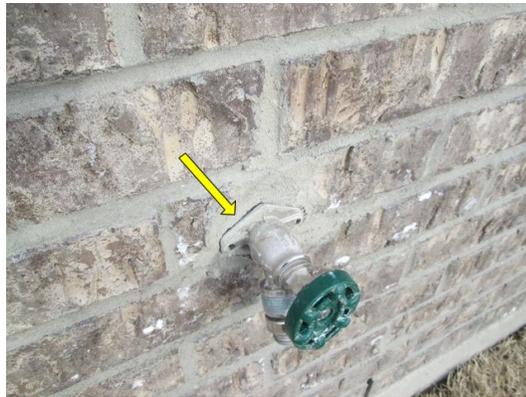
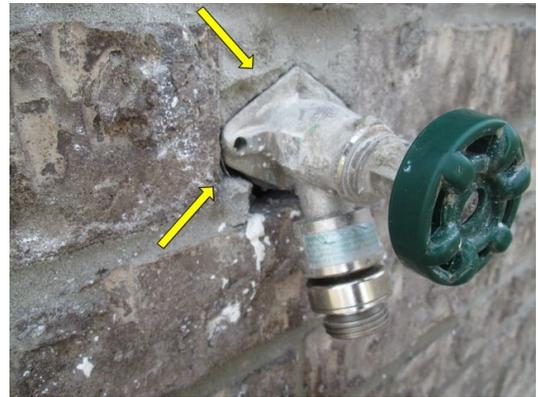
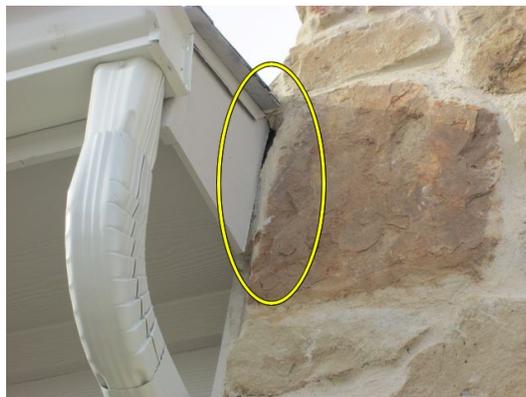
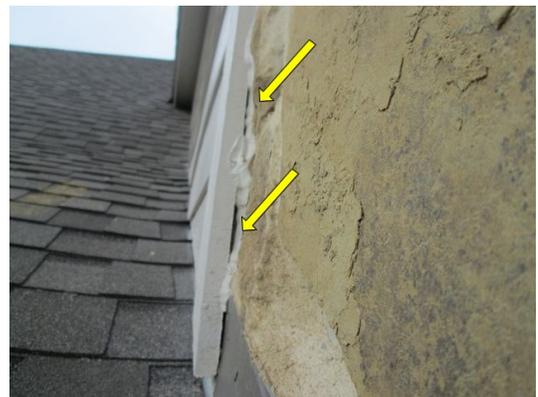
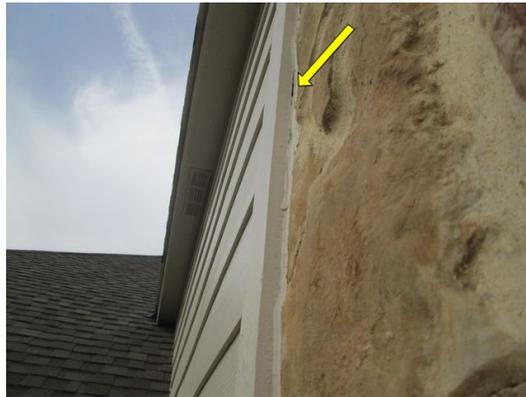
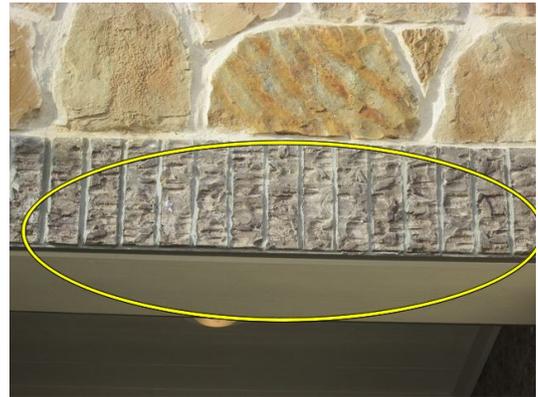
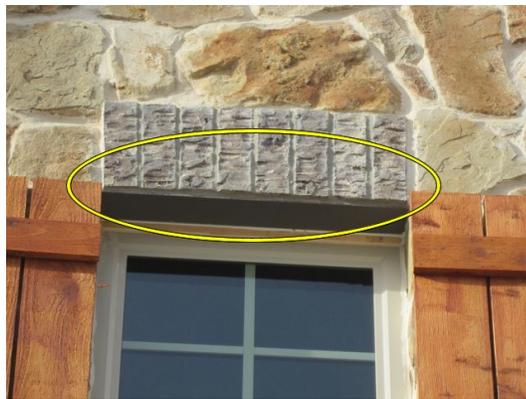
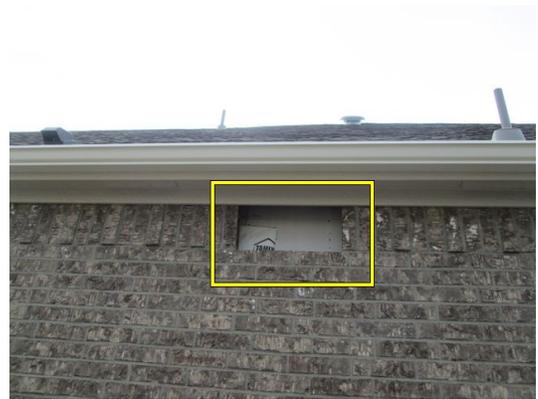
-Interior garage concrete area that has exposed rebar present.(See Photo for example)

-Exterior wall gaps and/or holes present, possible water penetration areas - front archway at both sides, front rock to wood accent piece, S/E upper eave corner, rear patio at one side, waste pipe areas, around exterior faucets.(See Photo for example)

-Exterior caulk needed at wood to brick and wood to rock vertical areas (suggest a check of all areas for missing and gaps), to prevent water penetration.(See Photo for example)

-Exterior wall weep holes appear to be missing over the front archway and over the front upper archway window.(See Photo for example)

-Exterior brick missing at the East wall (appears to be at the area where the range vent pipe may need to be ran, range vent pipe is not installed/present).(See Photo for example)

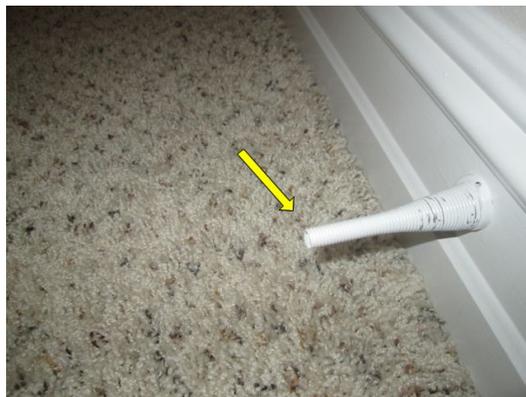
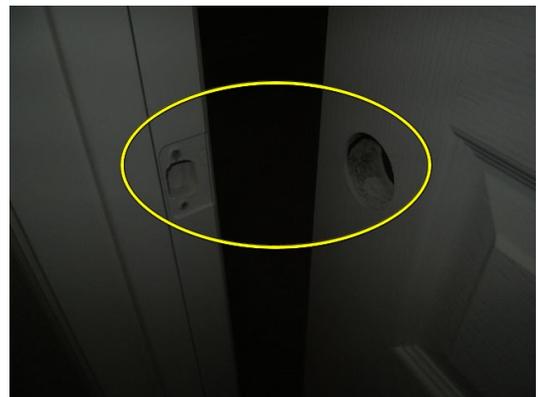
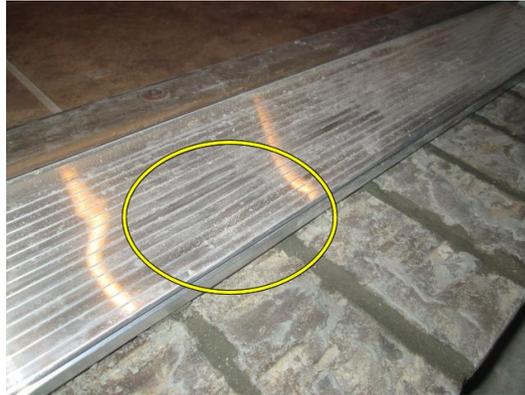
- Door stoppers missing at the hall bathroom, front bedroom closet, master bedroom closet
- Door stoppers damaged (plastic caps missing at various areas).(See Photo for example)
- Doorknob and hardware missing at one front bedroom.(See Photo for example)
- Garage to home metal threshold has a dent present.(See Photo for example)
- Master bathroom closet door is not catching at the striker plate area.
- Master bedroom double doors are not closing/latching properly (upper latch is damaged).

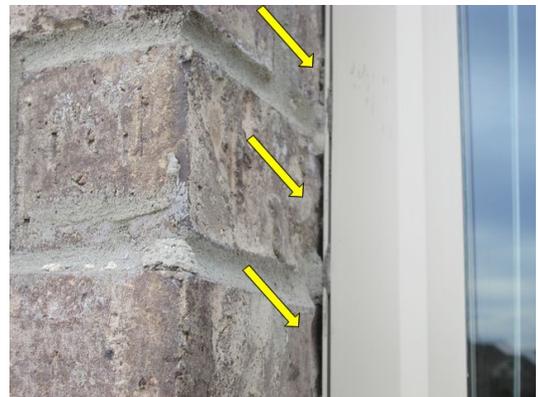
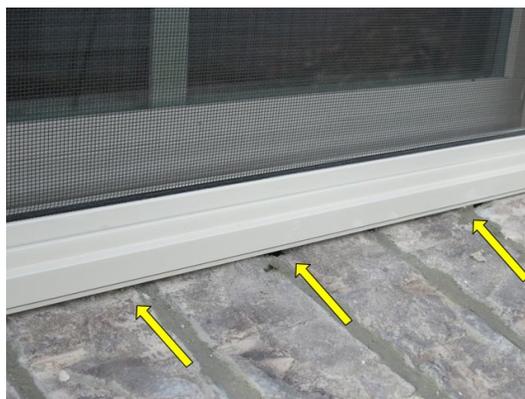
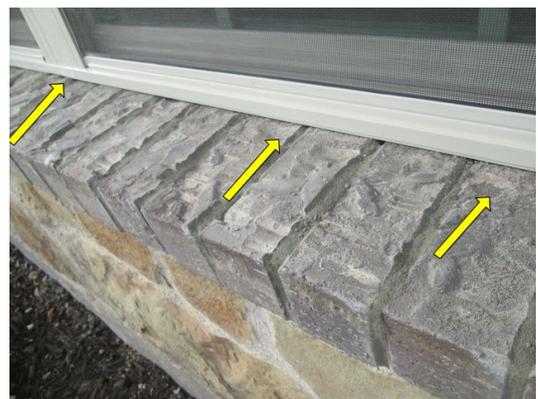
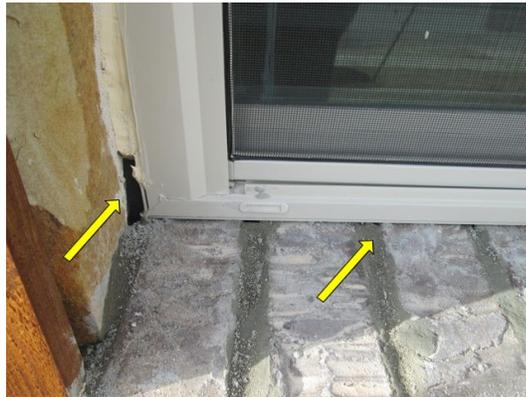
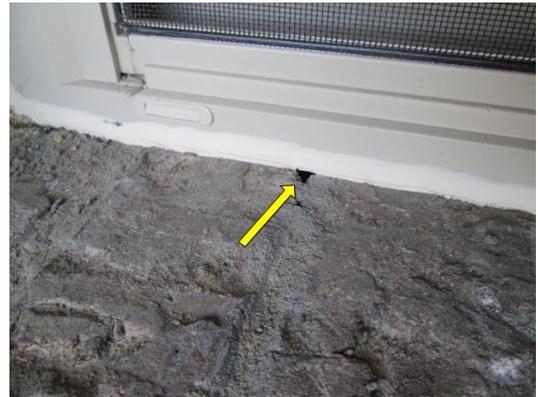
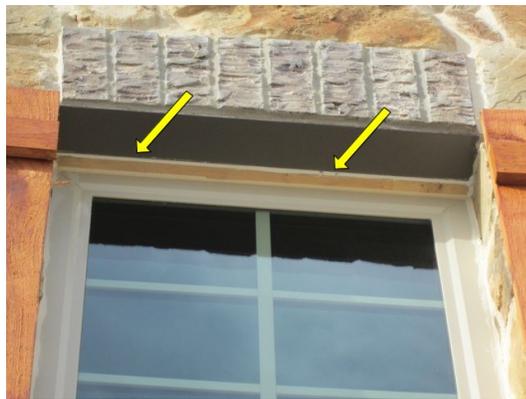
- Exterior caulking needed at window trim areas (several areas that have not been sealed and some sealed areas that have gaps present, suggest a check of ALL windows), possible water penetration areas.(See Photo for example)
- Exterior front upper archway window header with exposed wood present.(See Photo for example)

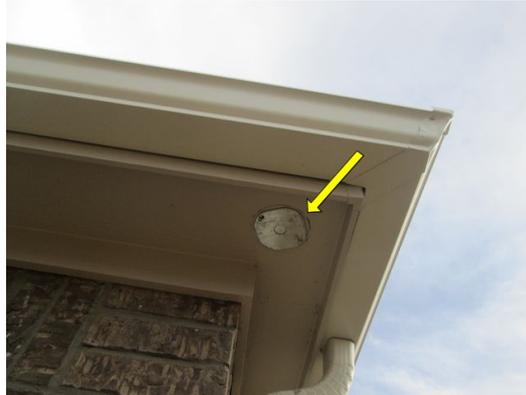
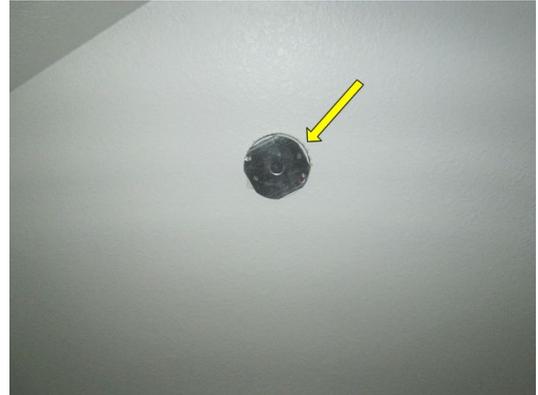
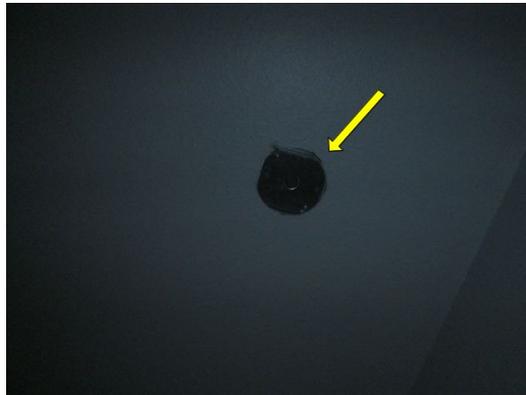
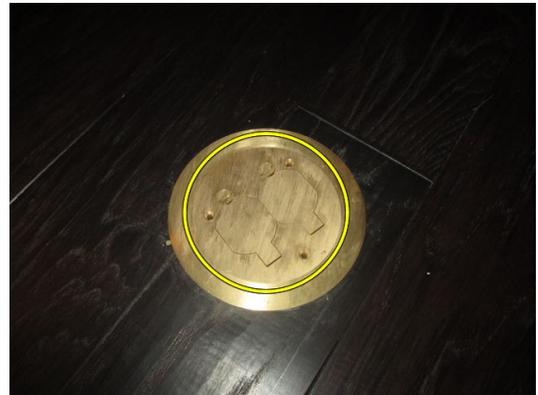
Type of Wiring: Copper
Comments:
-GFCI (Ground-Fault Circuit Interrupters) not in proper areas: Garage - 1, Kitchen Butler Area - 1

- Light covers missing at the kitchen pantry and the powder room.
- Light fixtures missing/not installed at the exterior flood light and two bedroom closets.(See Photo for example)
- Lights present with bulbs missing or not working at the attic, dining room, hall bathroom.
- Living room floor outlet cover is loose/missing all the screws.(See Photo for example)
- Wall switches to un-known locations (various areas).

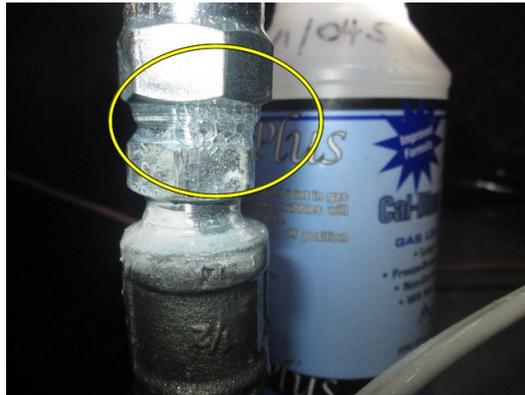
- Gas leak detected at unit flex line connection (this is at the top of the unit), suggest repair and full gas pressure test to home by specialist.(See Photo for example)

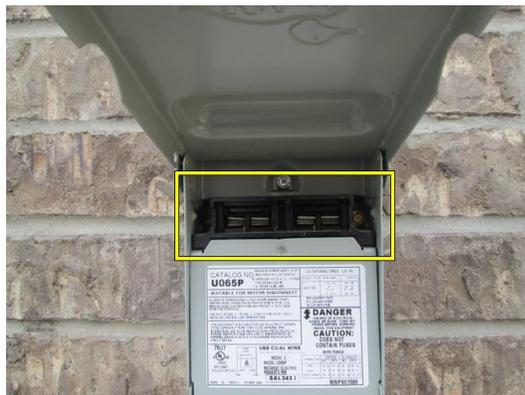
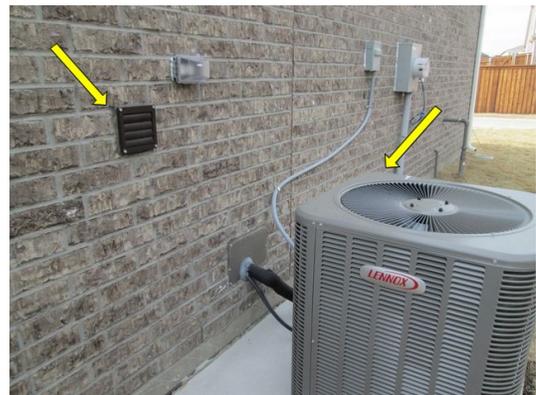
-Condenser unit electrical cut off (disconnect) is missing the disconnect blade handle device.(See Photo for example)

-Dryer vent termination is less than 6 foot from the AC unit.(See Photo for example)

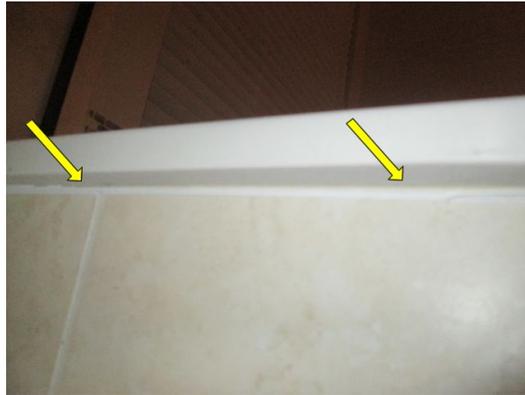
-Shower Stall area caulk/grout repairs needed at the under side of the seat ledge.(See Photo for example)

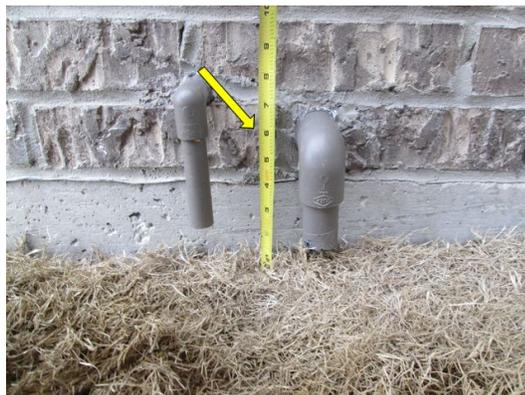
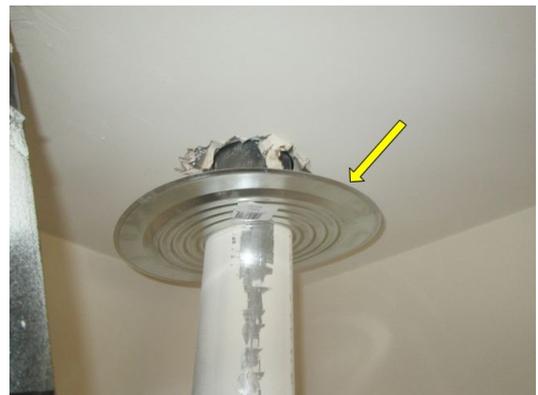
-Temperature and Pressure Relief line lacks proper termination. Recommended to exit to exterior, with an elbow pointing down, 6 inches to 24 inches from the ground.(See Photo for example)

-Drain pan line lacks proper termination. Recommended to exit to exterior, with an elbow pointing down, 6 inches to 24 inches from the ground.(See Photo for example)

-Ceiling flue pipe ring is loose/damaged.(See Photo for example)

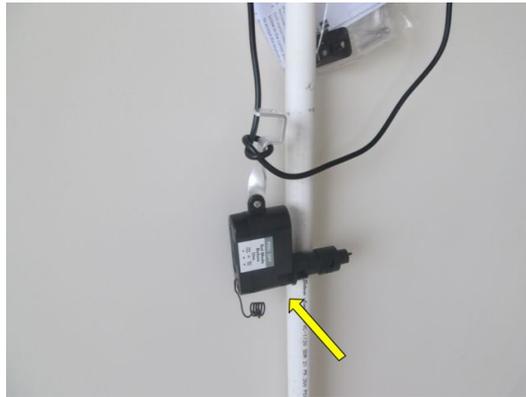
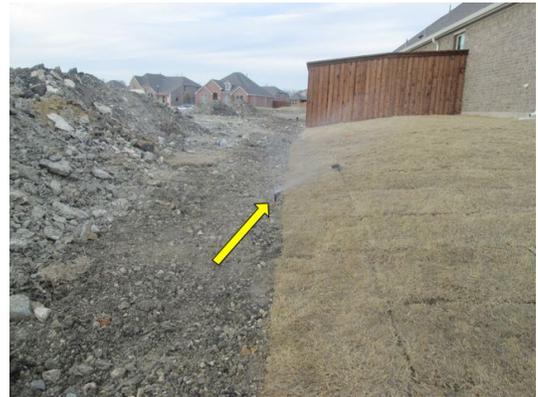
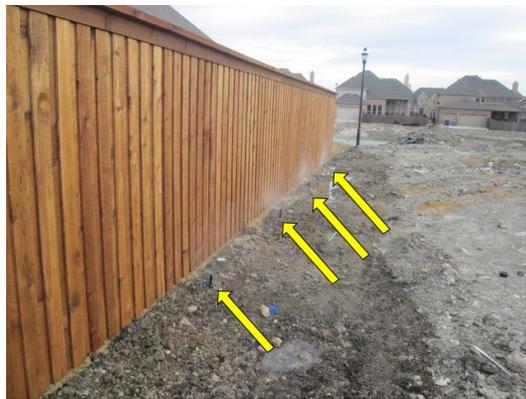
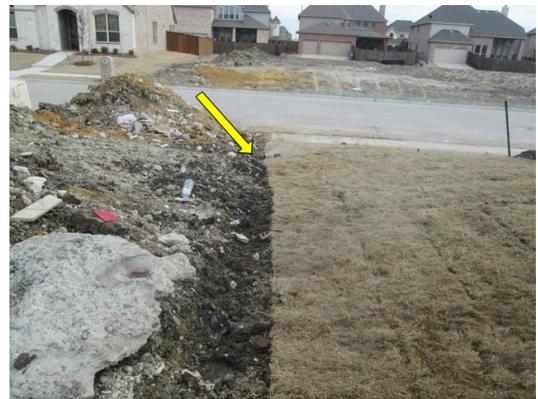
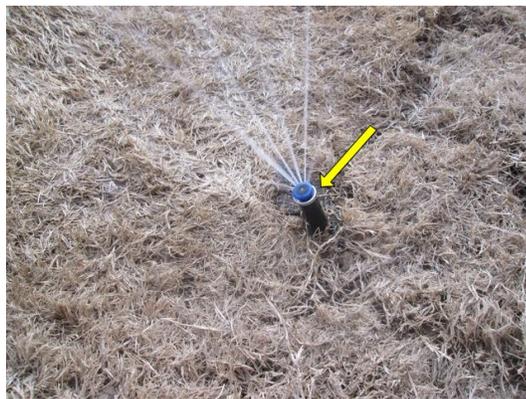
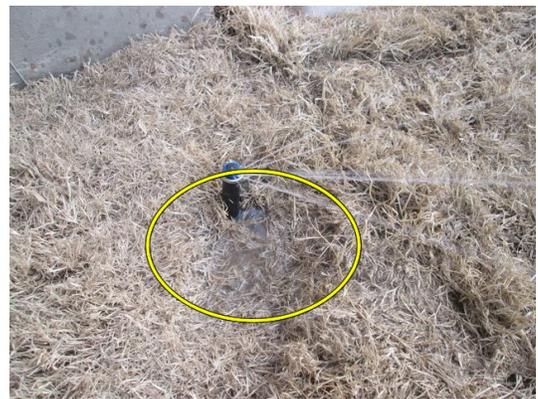
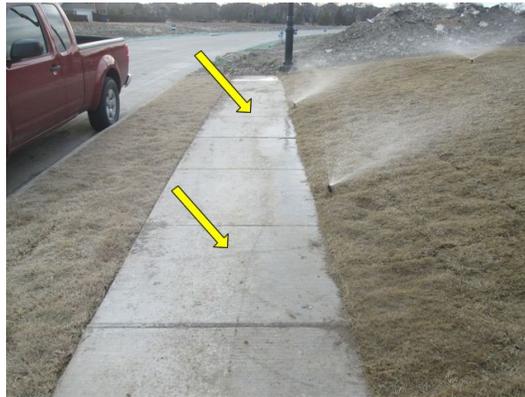
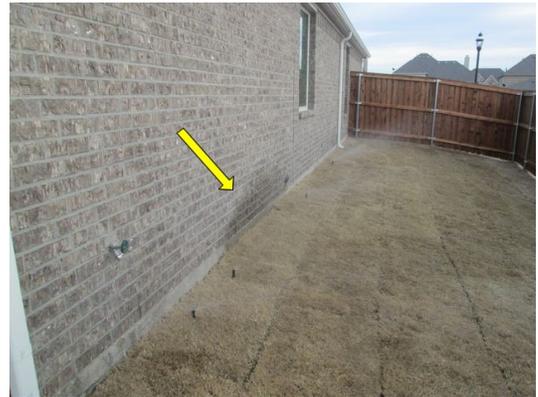
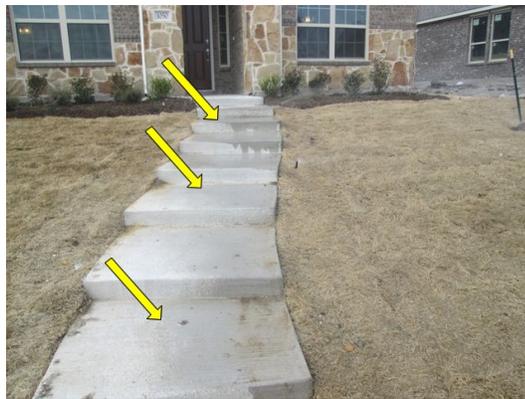
-Rain/freeze sensor exterior relay has not been installed, in the garage at the control box area.(See Photo for example)

-Heads viewed in zones #2, #4, #9 that do not appear to be on the correct property line (some are located on the wrong side of the fence). Suggest a check of all heads to make sure they are located on this home properly.(See Photo for example)

-Leaning heads viewed at various areas, suggest check with repairs as needed to all.(See Photo for example)

-Zone #6 - one head damaged/leaking at the back yard near the gate.(See Photo for example)
