PROPERTY INSPECTION REPORT

Concerning: Your Street - 1959 home, Any City, TX 75070
(Address of Inspected Property)

By: Ricky Cornick, Lic #6229 02/01/2009
(Name and License Number of Inspector) (Date)

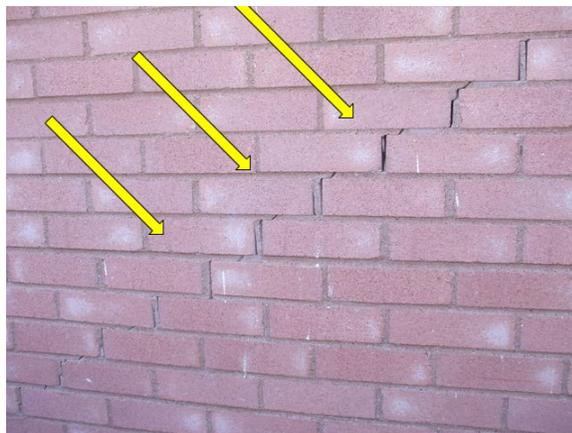
- Door frame movement observed during the inspection.
- Window frame movement observed during the inspection.
- Exterior wall cracks observed during the inspection. (See Photo for example)

- Exterior foundation face crack areas observed during the inspection.
- Interior wall cracks observed during the inspection (various areas).
- Interior ceiling cracks observed during the inspection (various areas).

- Possible sloping floors observed during the inspection.
- Large trees observed close to home's foundation.
- Poor water maintenance observed at the time of the inspection, soil pulling away from the foundation face or overly dry.

- Foundation appears to have some movement observed at the time of the inspection. Suggest report by a structural engineer if so chosen to provide suggestions as to what, if any, corrective actions should be taken.

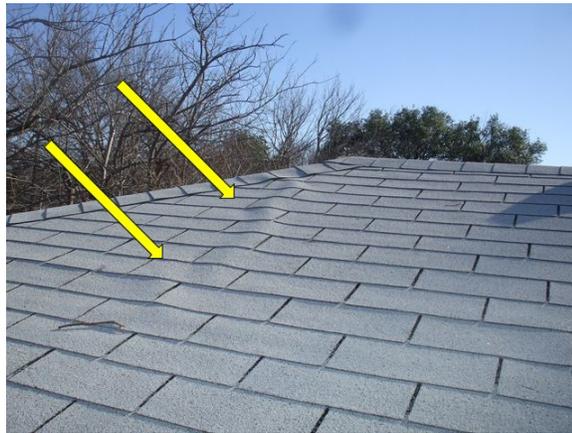
- Roof shingles damaged at various areas. Both scuffed and buckled areas. (See Photo for example)
- Tree limbs too close to roof, need to be trimmed to prevent damage. (See Photo for example)
- Roof gutters have debris present, suggest cleaning of all gutter systems.
- Roof gutter extensions needed to extend discharges away from the foundation.

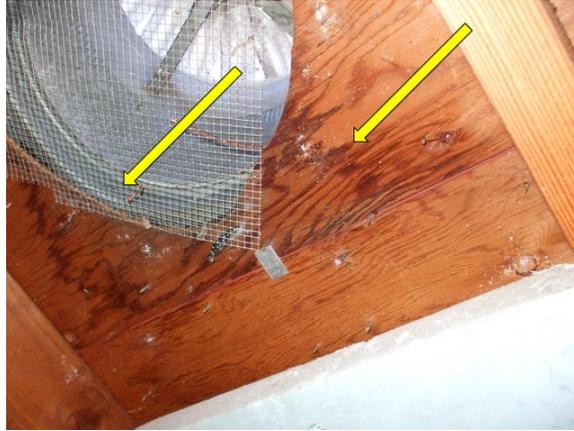
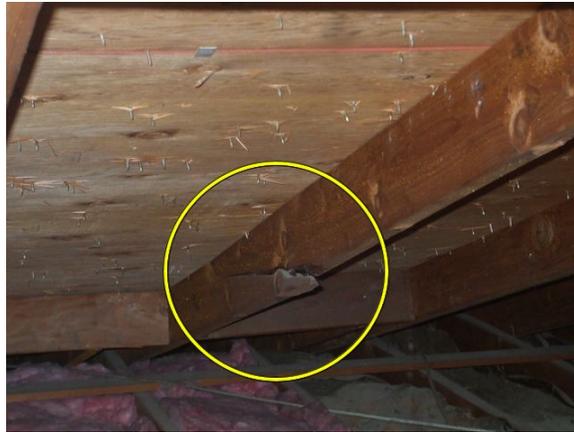
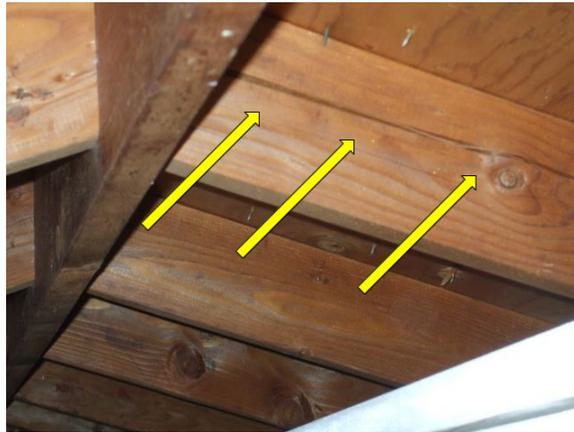
- Soffit vent covers damaged and/or loose.
- Attic area appears to have poor ventilation. Limited number of soffit vents present.
- Vent wire mesh damaged and/or torn. Without proper wire mesh present animals or birds can get into the attic area.
- Attic appears to have poor insulation present.
- Wires are too close to the attic opening.
- Previous water stains viewed from inside attic area, unknown if water stains are from current leaks. Suggest evaluation by roofing specialist if so chosen. (See Photo for example)
- Rafters split and/or damaged areas viewed from inside the attic area. (See Photo for example)
- Collar Ties split and/or damaged areas viewed from inside the attic area. (See Photo for example)
- Limited access due to duct work at East attic area, this area could not be properly inspected.
- Attic door not sealed properly.

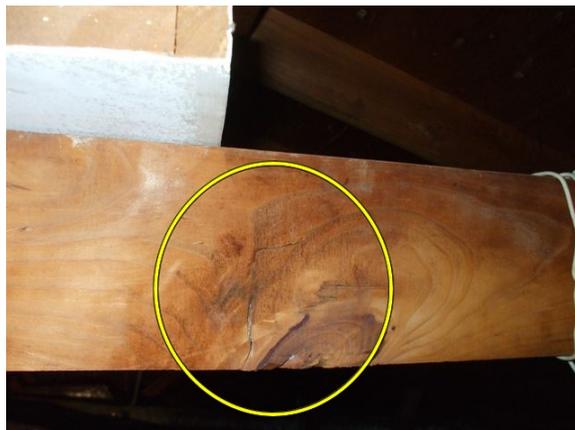
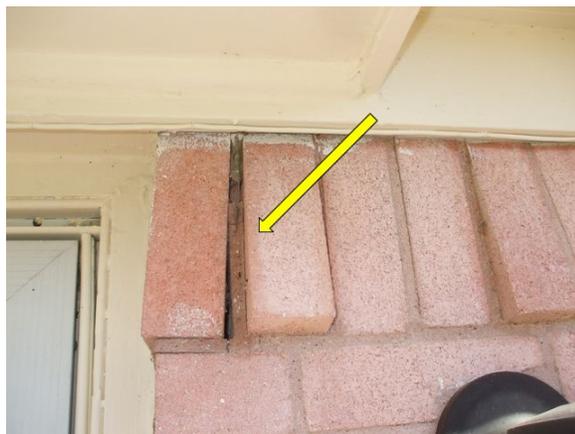
- Interior wall water stains present, unknown if water stains are from current leaks.
- Interior wall cracks present at various areas.
- Interior walls that have holes present at various areas. See garage areas.
- Interior walls that appear to have possible previous repairs present.
- Exterior brick appears to have loose areas present (various areas). (See Photo for example)
- Exterior mortar is separated or missing at various areas.
- Exterior wall gaps and/or holes present at various areas, possible water penetration areas.
- Exterior window sill gaps present, possible water penetration areas. Suggest caulk or silicone to seal all exposed areas.
- Exterior, form board nails sticking out from foundation face, suggest to remove/cut even at concrete.
- Exterior wing wall damaged areas observed.

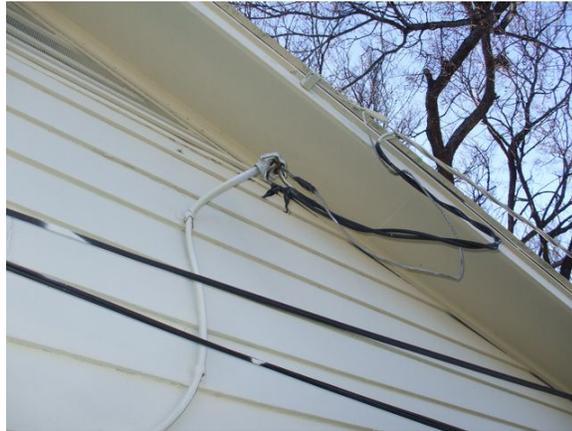
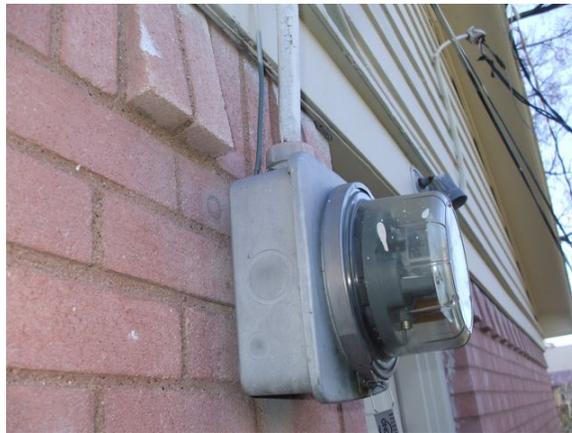
- Meter box damaged at exterior wall. Buzzing noise coming from meter area.
- Meter box not mounted properly/loose at exterior wall. (See Photo for example)

- Electrical service drop wires appear to be damaged/missing insulation. (See Photo for example)
- Electrical service drop wires have tree limbs touching.

- Electrical service drop appears to be at improper height.
- Electrical service drop is loose and/or pulling away from the home. (See Photo for example)

- Electrical service drop has improper drip loop at weather head. (See Photo for example)
- Electrical service drop weather head appears to be loose and/or damaged. (See Photo for example)

- Recommend service & complete system check by licensed electrician due to the defects observed.

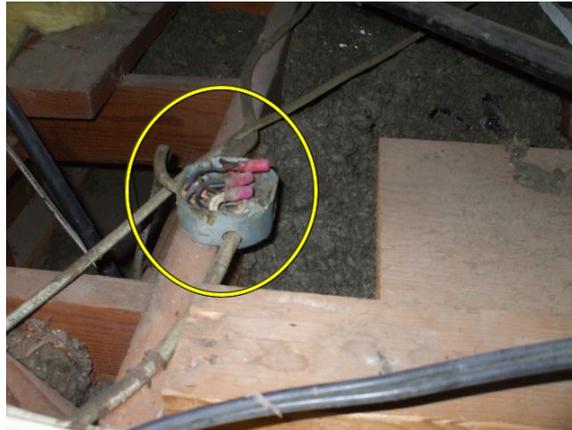
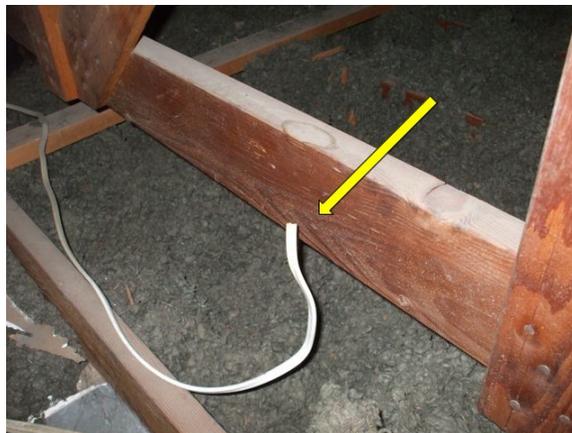
- Wall switch covers missing and/or damaged at various areas.
- Wire splices and/or wire ends exposed (all wire splices or ends should be in junction boxes that are properly mounted) viewed in the: Attic (See Photo for example)

- Exposed wires at the: Garage, Attic , Under Kitchen Sink
- Three prong dryer out present (if accessible), many new dryers include four prong cords.
- House wired with a two-wire system, most outlets and fixtures are not grounded.

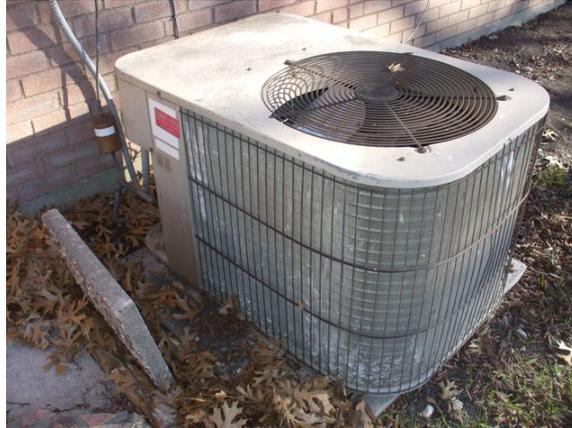
- Freon lines not properly insulated at: Exterior (See Photo for example)
- Condenser unit would not cycle on, unit would not operate properly at the time of the inspection.
- Condenser unit has exposed wires present.
- Condenser unit is at or below grade level, needs to be raised.
- Condenser unit coils are dirty/damaged/flattened, need to be cleaned and serviced. (See Photo for example)
- Condenser unit electrical cut off (disconnect) is damaged/loose at wall with missing latch.
- Air handler unit would not cycle on, unit would not operate properly at the time of the inspection.
- Unit has no visible P trap at the primary drain line.
- Unit has no auxiliary (secondary) drain line and/or capped off at unit.
- Unit plugged into non grounded outlet, ground at plug has been cutoff.
- Due to defects observed, recommend service and systems evaluation by qualified HVAC specialist.

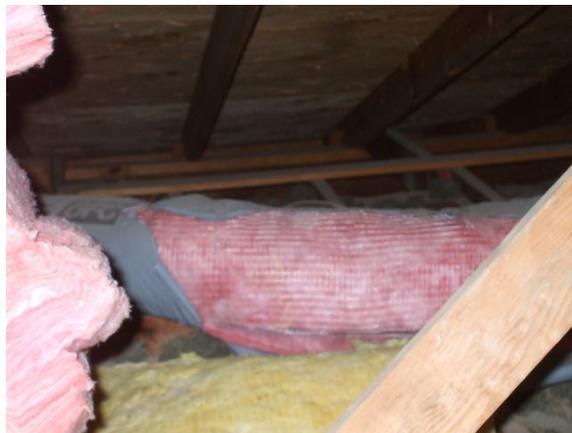
- Duct coverings damaged and/or missing.
- Duct coverings "Gray Type" present with heavy damage present or are beginning to deteriorate, suggest replacement and/or repair to duct work. (See Photo for example)
- Plenum damaged, repairs needed.

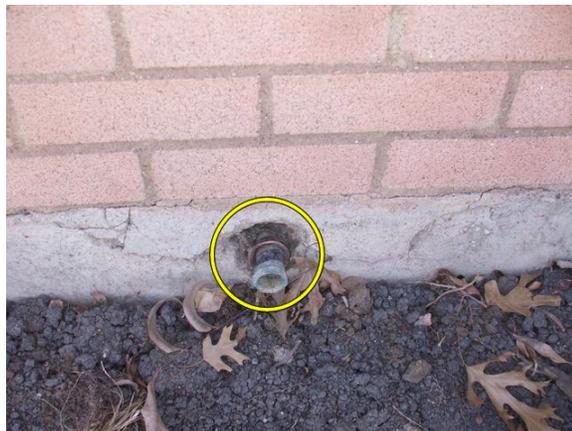
- AC primary drain line appears to terminate at the exterior of home. S/E corner. (See Photo for example)
- Home appears to have cast iron drain pipes present, suggest specialist evaluate if so chosen.

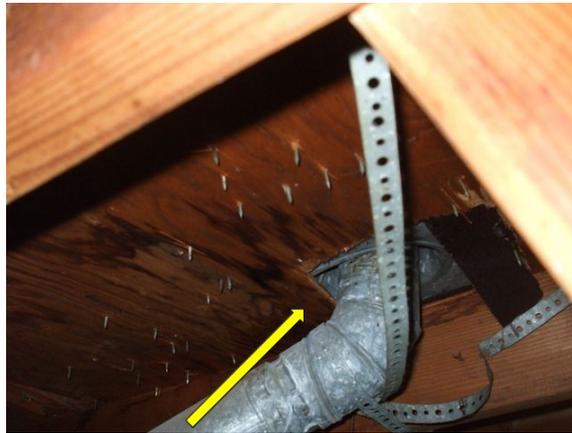
- Temperature and Pressure Relief line improperly routed, lacks gravity drainage.
- Temperature and Pressure Relief line appears to have been reduced in size from the valve.
- Flue appears to be in contact or too close to combustibile materials. (See Photo for example)
- Flue pipe does not appear to be double wall pipe through ceiling attic and/or roof.
- No drain pan/drain line for pan present under unit.
- Gas unit has rust on and in burner area.
- Gas unit has improper flame color.
- Gas unit present with inadequate ventilation for combustibile air.
- Gas unit present with inadequate ventilation, closet doors are not sealed properly to living area.
