PROPERTY INSPECTION REPORT

Concerning: Builders say you do not need a third party inspector...., DFW Area, TX 75070
(Address or Other Identification of Inspected Property)

By: Rick Cornick, Lic #6229 01/22/2014
(Name and License Number of Inspector) (Date)

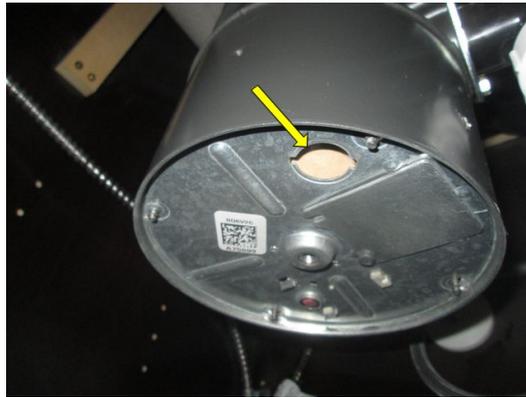
B. Food Waste Disposers

Comments:
-Unit not working, no power cord present.(See Photo for example)

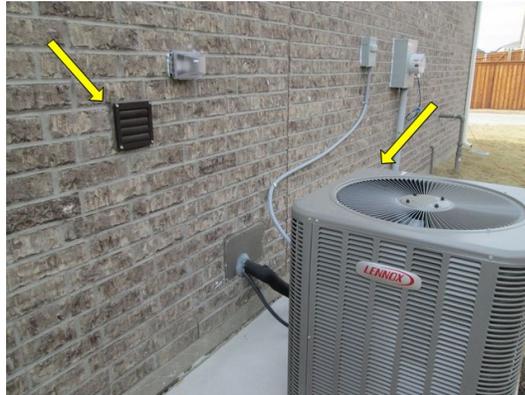
-Dryer vent termination is less than 6 foot from the AC unit.(See Photo for example)
